Manhole Inspection Summary

Manhole # S01CC2011MH

Insp Date: **7/24/06 8:58 AM**

Location Address: **6410 CROSS COUNTRY BLVD** Cross Street: **BANCROFT RD**

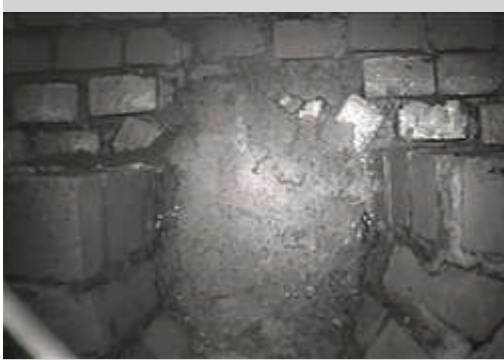
Adjustment infiltration. Corroded steps.
Evidence of surcharge - Bench debris.

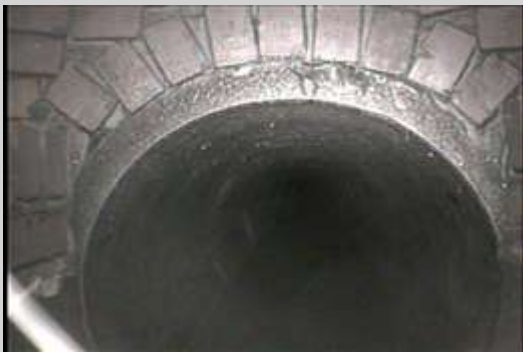
21 in. Circular Gravity Sewer Pipe Out @ 12 O'Clock

Infiltration: **Evidence** Pipe Seal Cond: **Unknown**
